Status of ADEOS-II

- Investigation Status of Anomaly -

Yasushi Kojima
ADEOS-II Project, JAXA

The 38th ARGOS Operation Committee Meeting
30 June, 2004
Monterey, USA

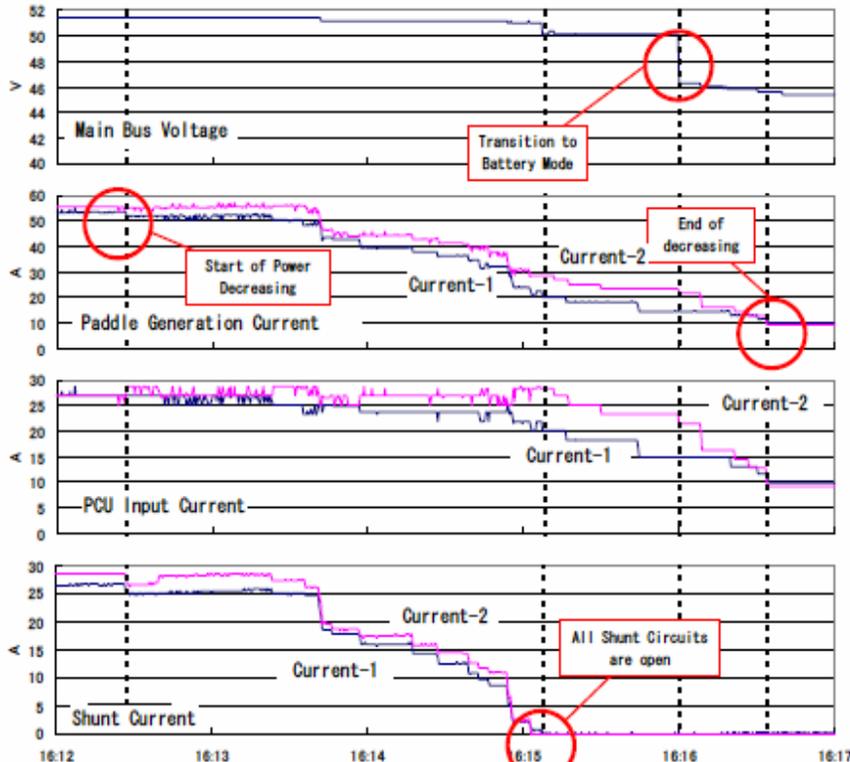
Telemetry Data for Generation Power

Start of Power Decreasing Around 16:12:25

Main Bus Voltage is maintained by opening shunt circuits

Around 16:15:10

Main Bus Voltage is maintained by reducing the battery charging current

End of decreasing Around 16:16:30

Battery Discharging (until communication link loss)

Around 16:16:00

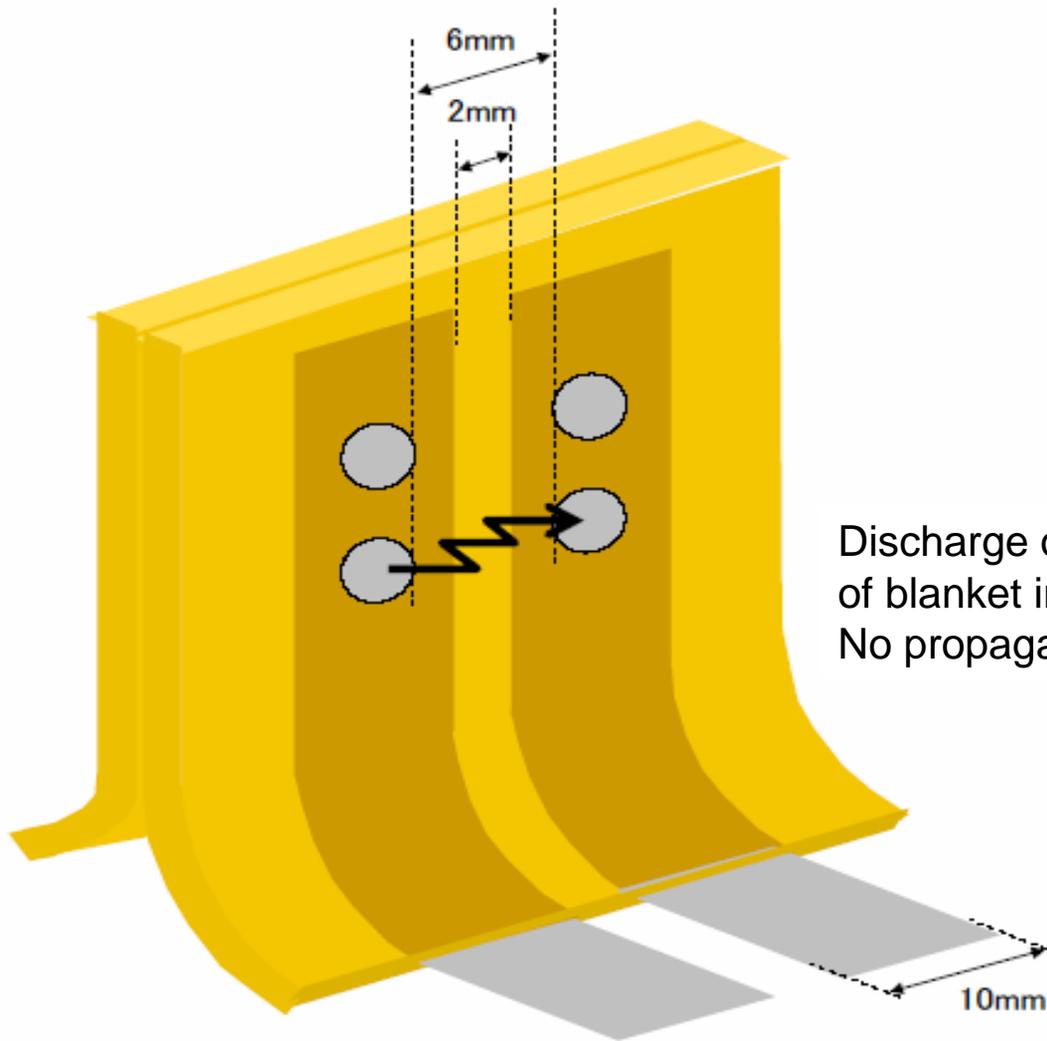
Hypothesis 1-2 and 1-3

Discharge occurred between lands in joint of blanket in laboratory tests.
No propagation observed.

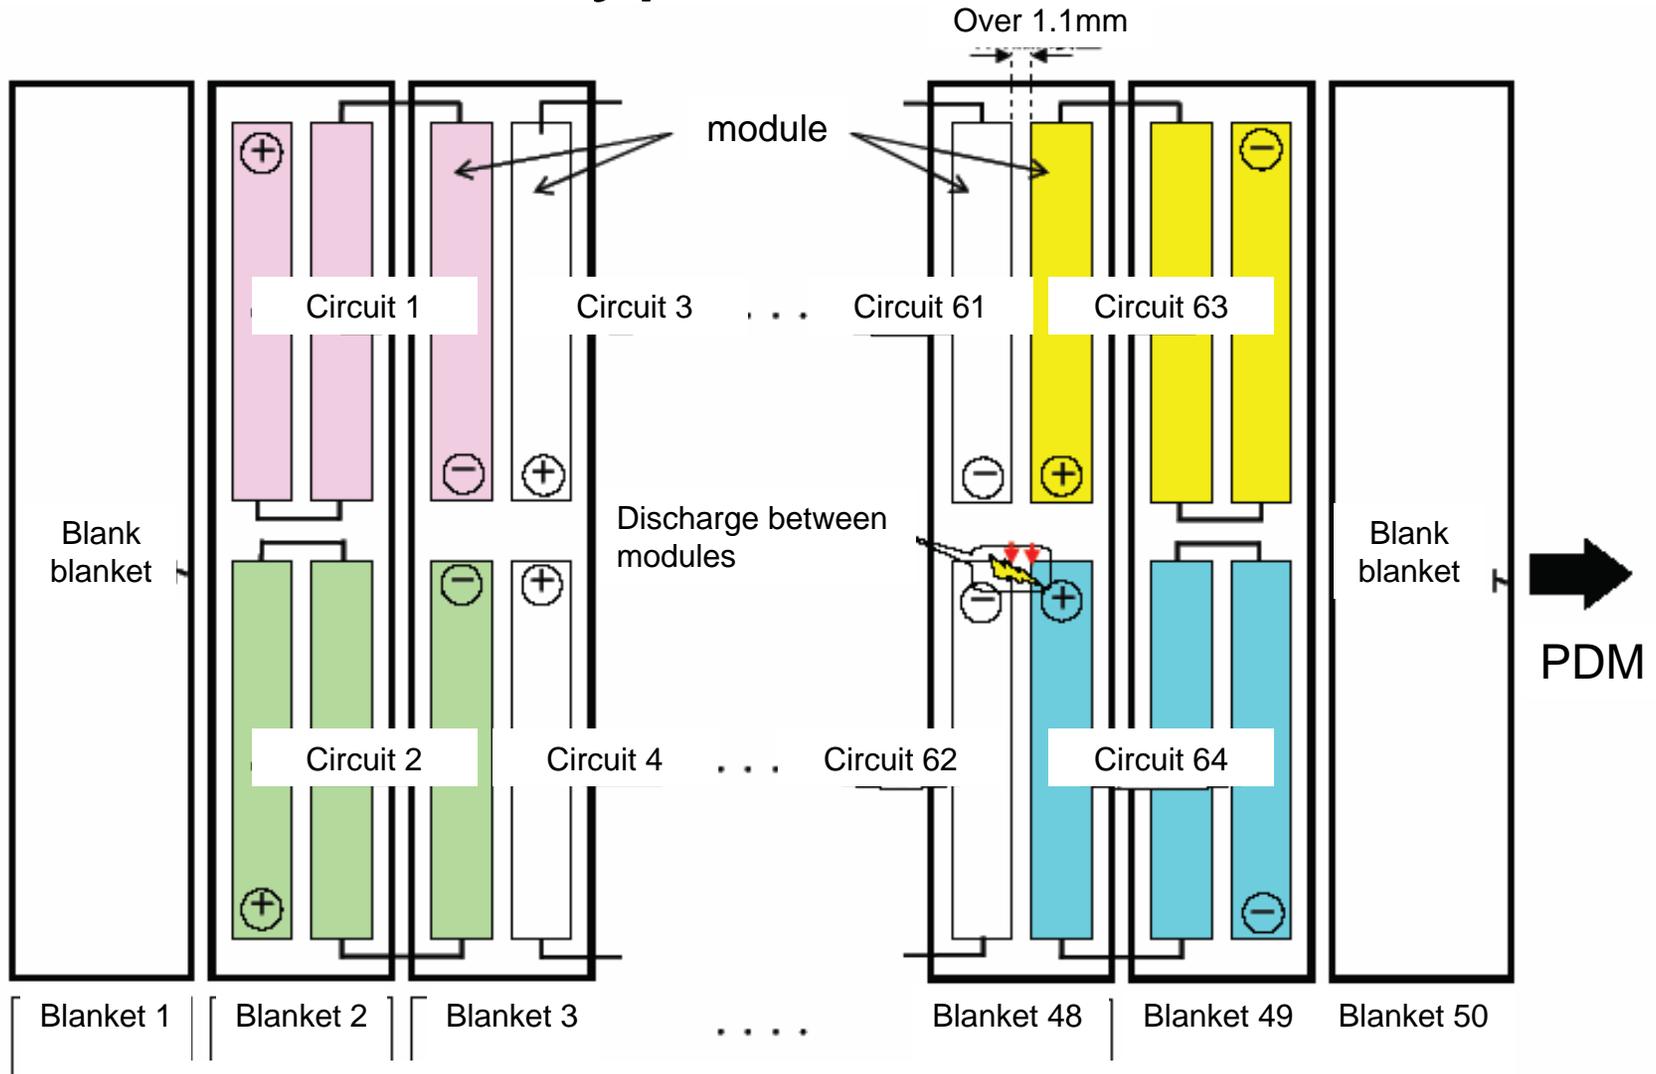
Hypothesis 1-4

Discharge occurred between modules in laboratory tests when voltage potential was greater than 130V. No propagation was observed. .

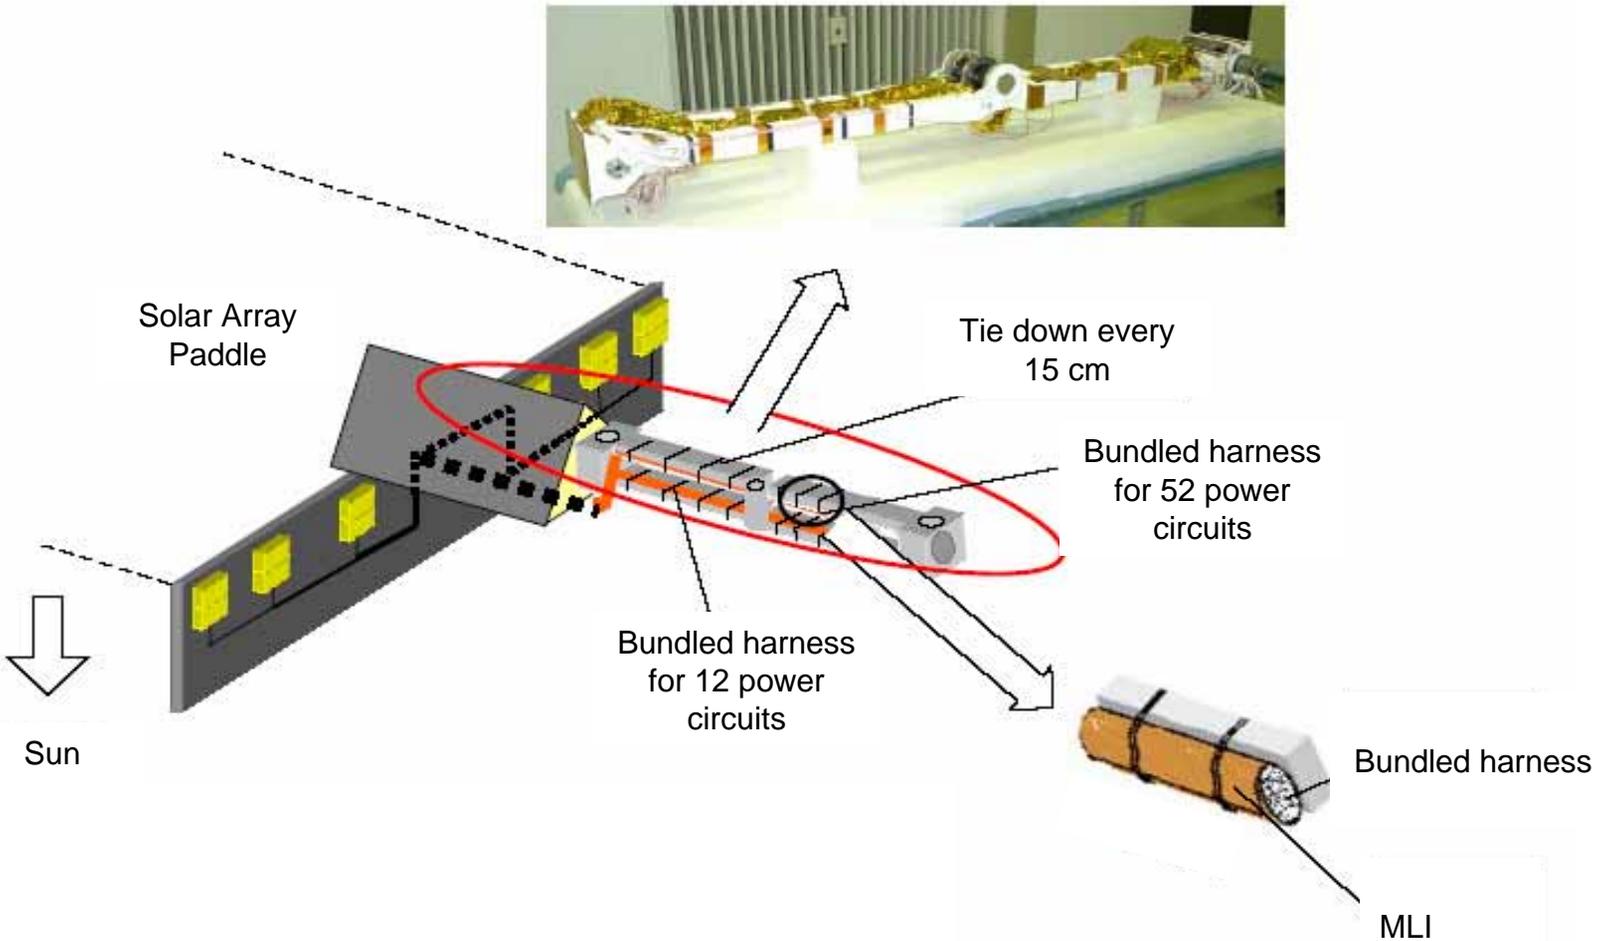
Hypothesis 2-1 to 2-4

MLI surrounding harness did NOT ground. MLI might be charged up when spacecraft passed auroral bands.

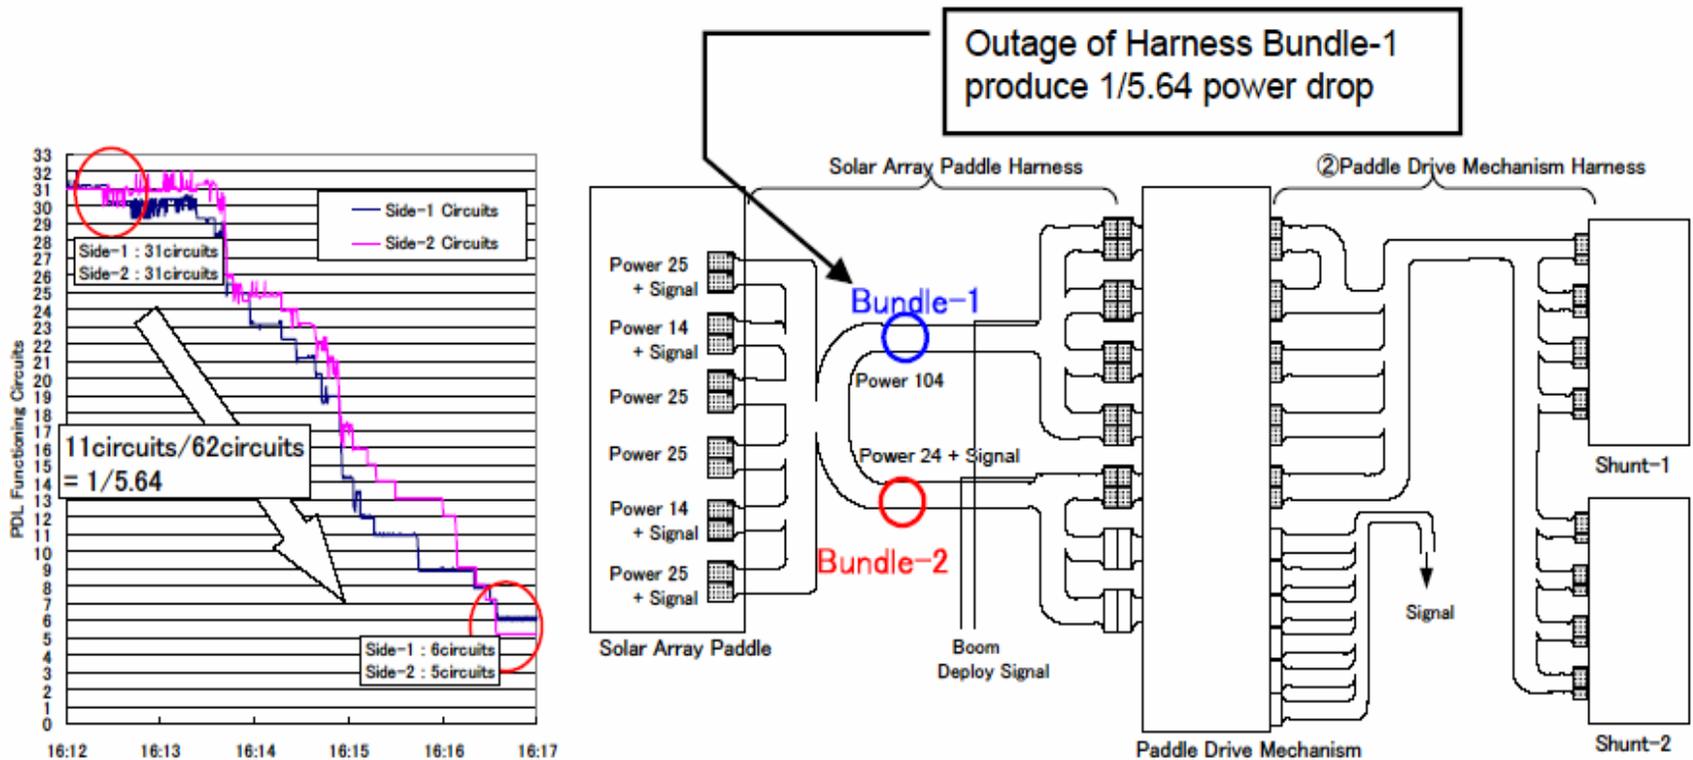
Bundled Harness

Solar Paddle Harness outage is considered to have the highest possibility.
 → Anomaly on the one of two bundled harness can explain TLM behavior very well.

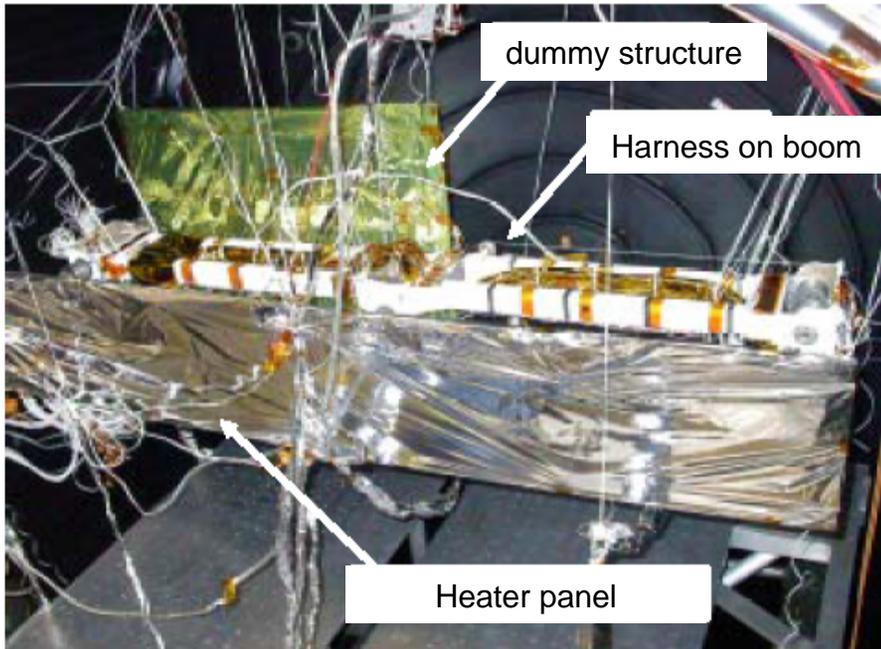
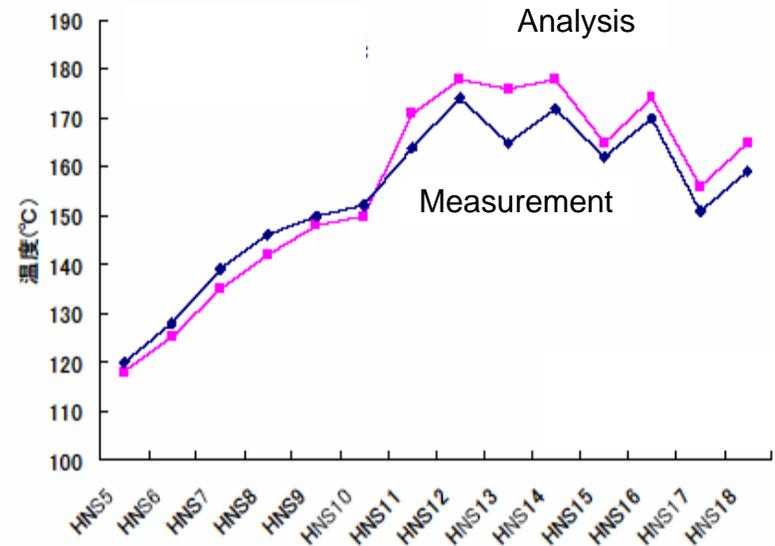
Temperature of Harness

Highest temperature of the harness might be 245 degree C. Temperature rating for the harness is 200 degree C.

High temperature produced outgas and discharge might occur easily.

High temperature might produce insulator cracks. 21

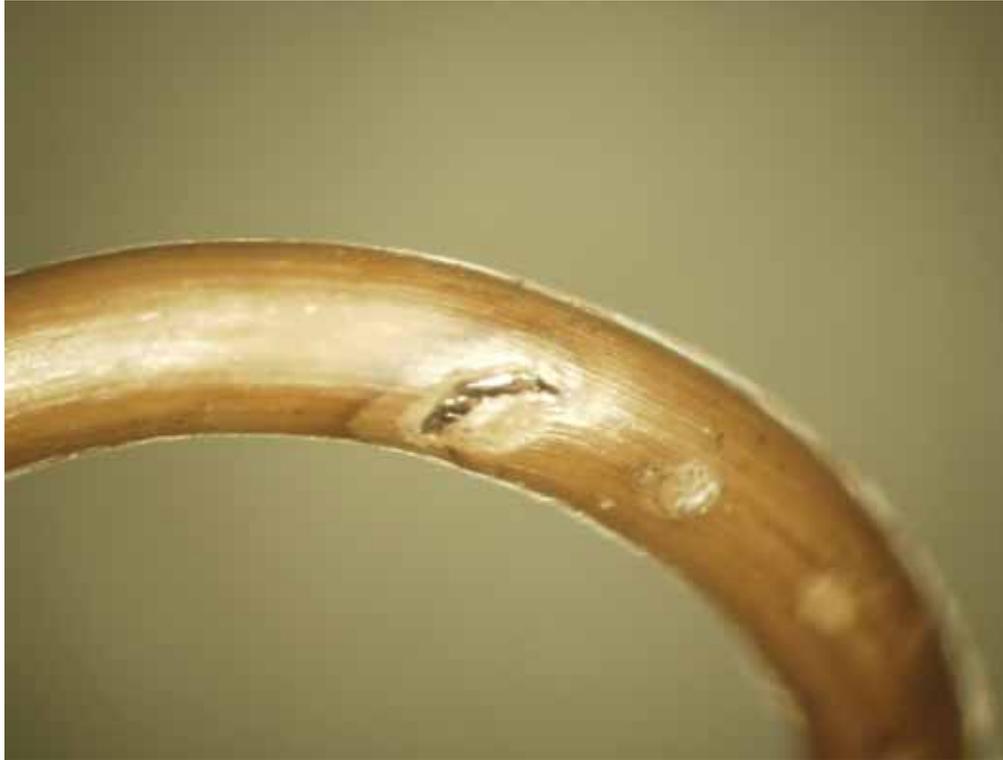
Cracks on Harness Insulator

Cracks were found on harness insulator after thermal cycle laboratory test. (100 – 250 degree C)
Another possibility is that space debris made cracks on-orbit.

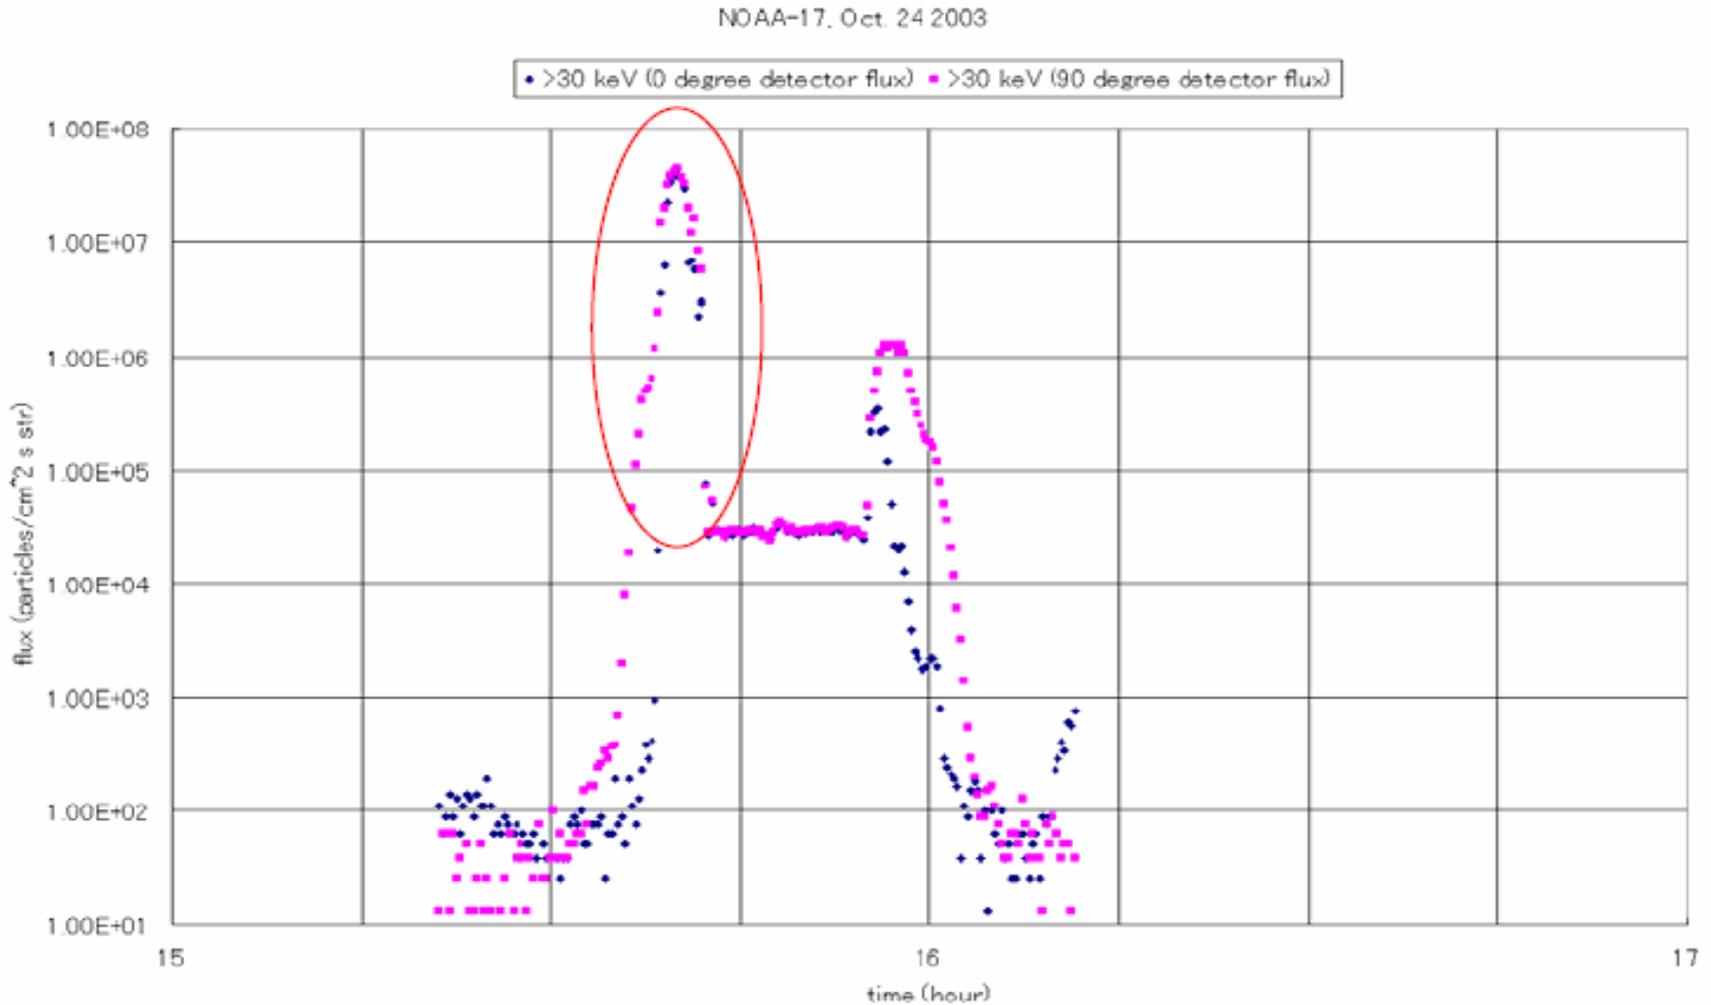
Energetic Electron on 24/10/2003

High electron flux might make MLI charged up.

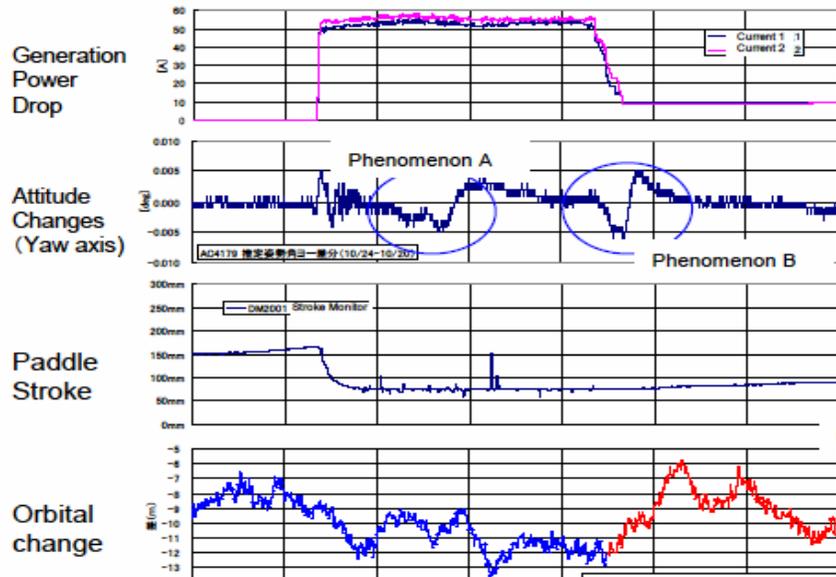
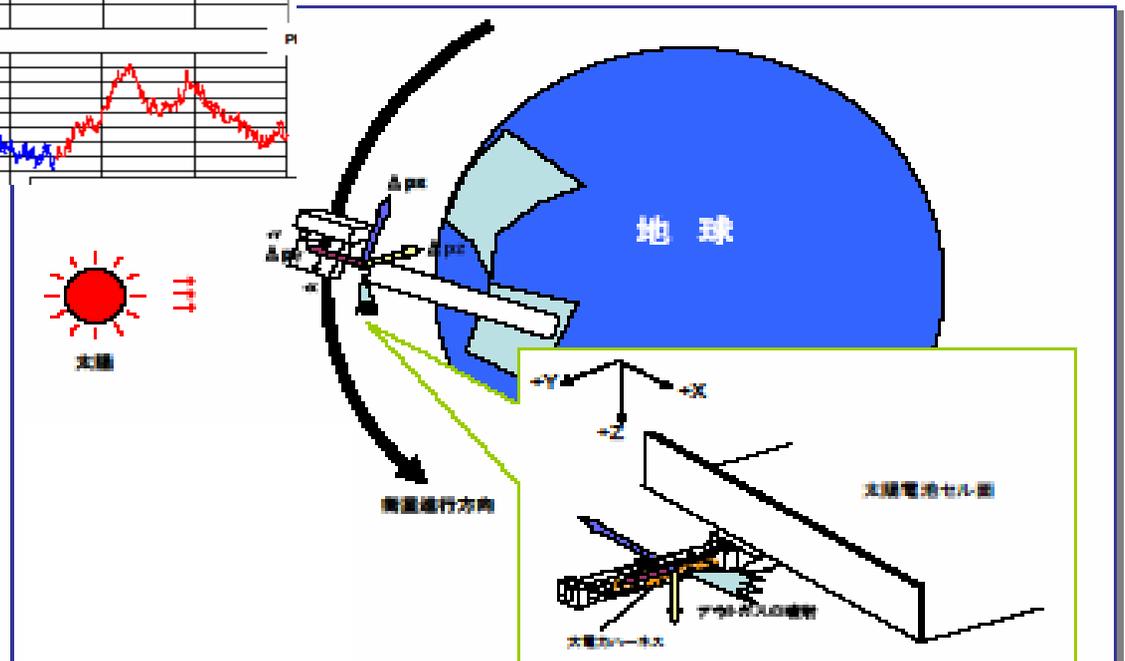
Outgas from Harness

Outgas from harness can explain attitude and orbit changes.
