Status of ADEOS-II

- Investigation Status of Anomaly -

Yasushi Kojima
ADEOS-II Project, JAXA

The 38th ARGOS Operation Committee Meeting
30 June, 2004
Monterey, USA

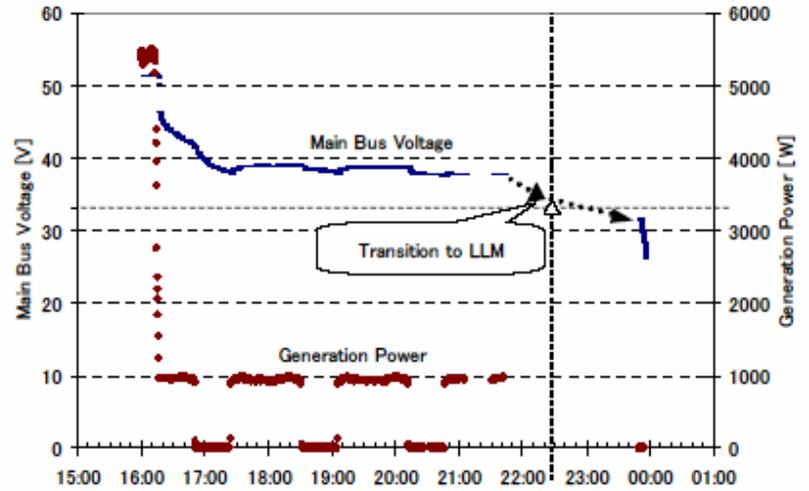
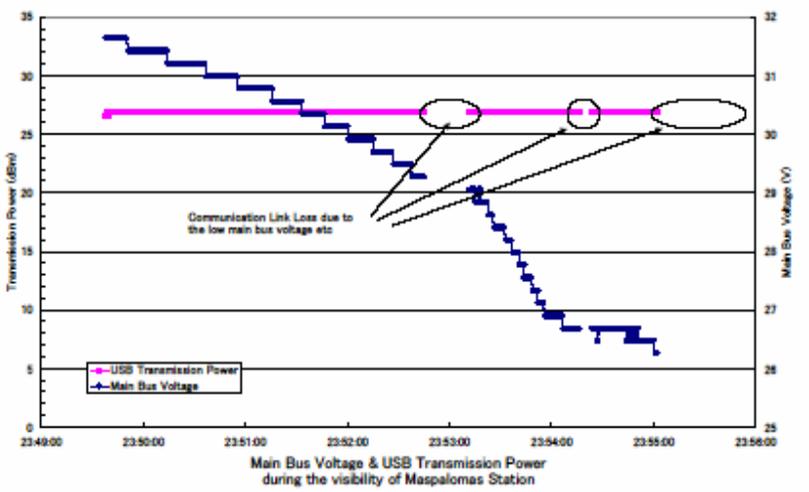
Main Bus Voltage & USB Transmission Power during the visibility of Maspalomas Station

Start of Power Decreasing Around 16:12:25

Main Bus Voltage is maintained by opening shunt circuits

Around 16:15:10

Main Bus Voltage is maintained by reducing the battery charging current

End of decreasing Around 16:16:30

Battery Discharging (until communication link loss)

Around 16:16:00

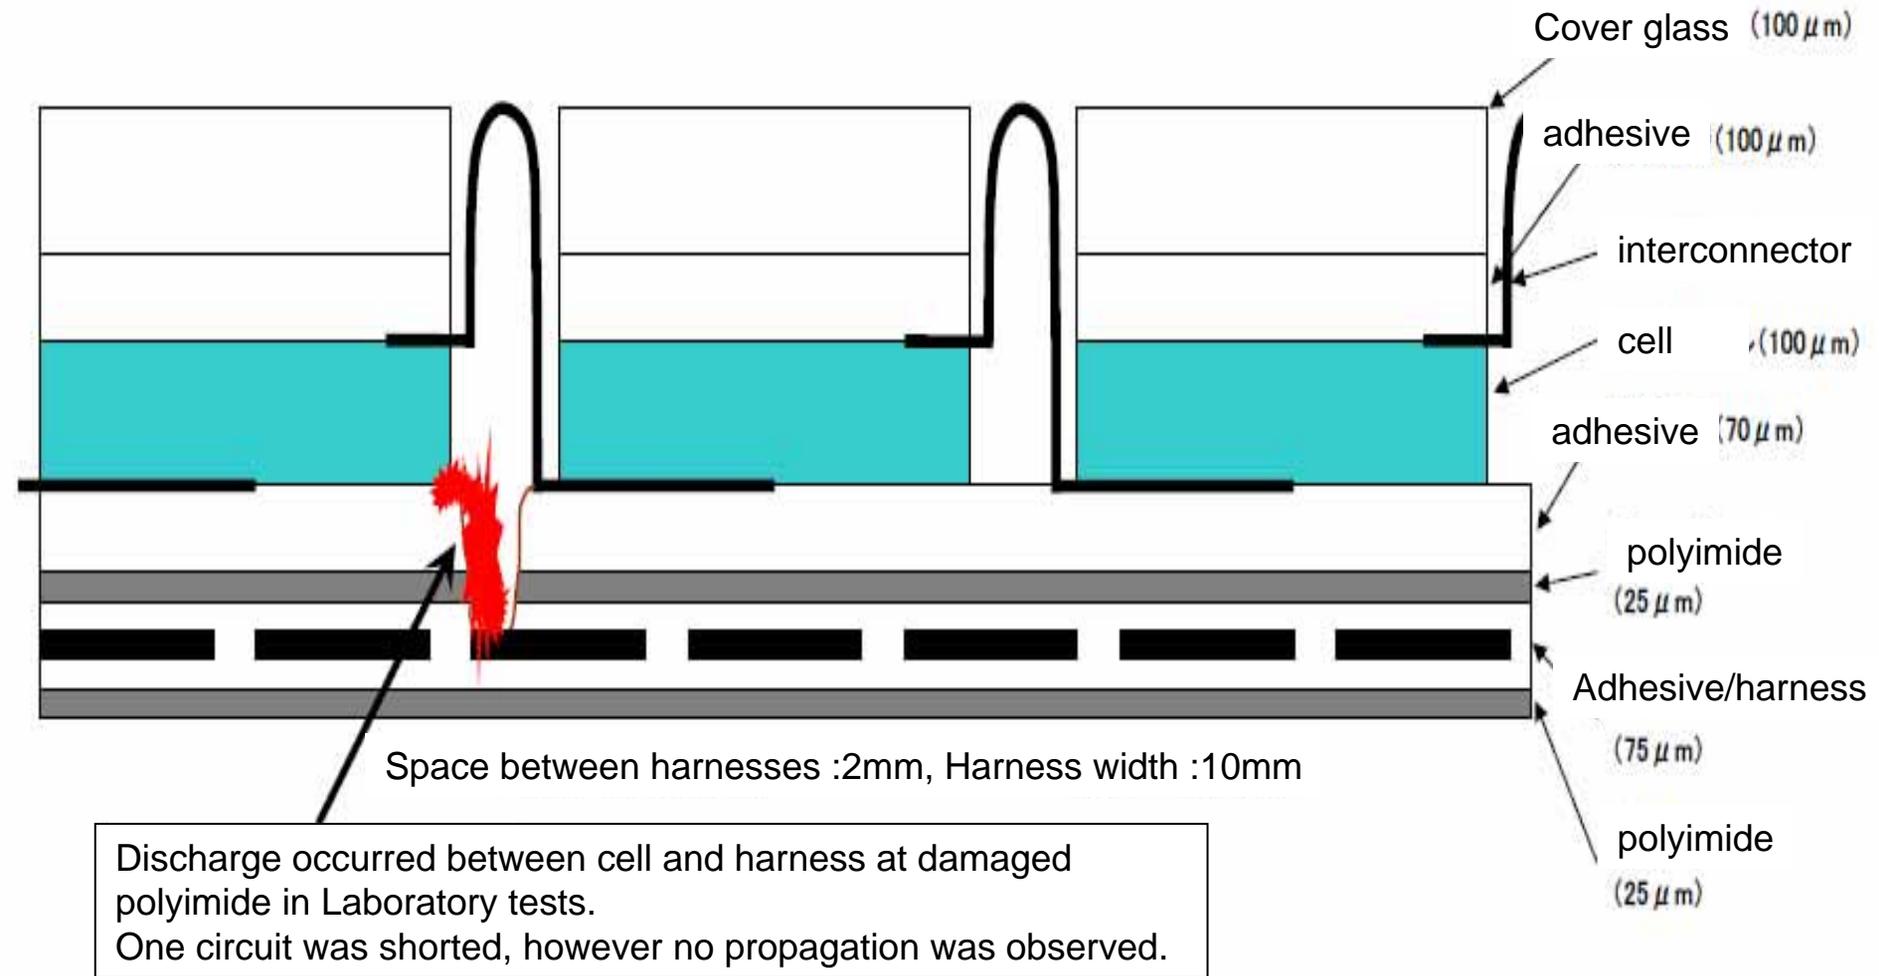
Hypothesis 1-1

1-1) Short between Cell and Harness

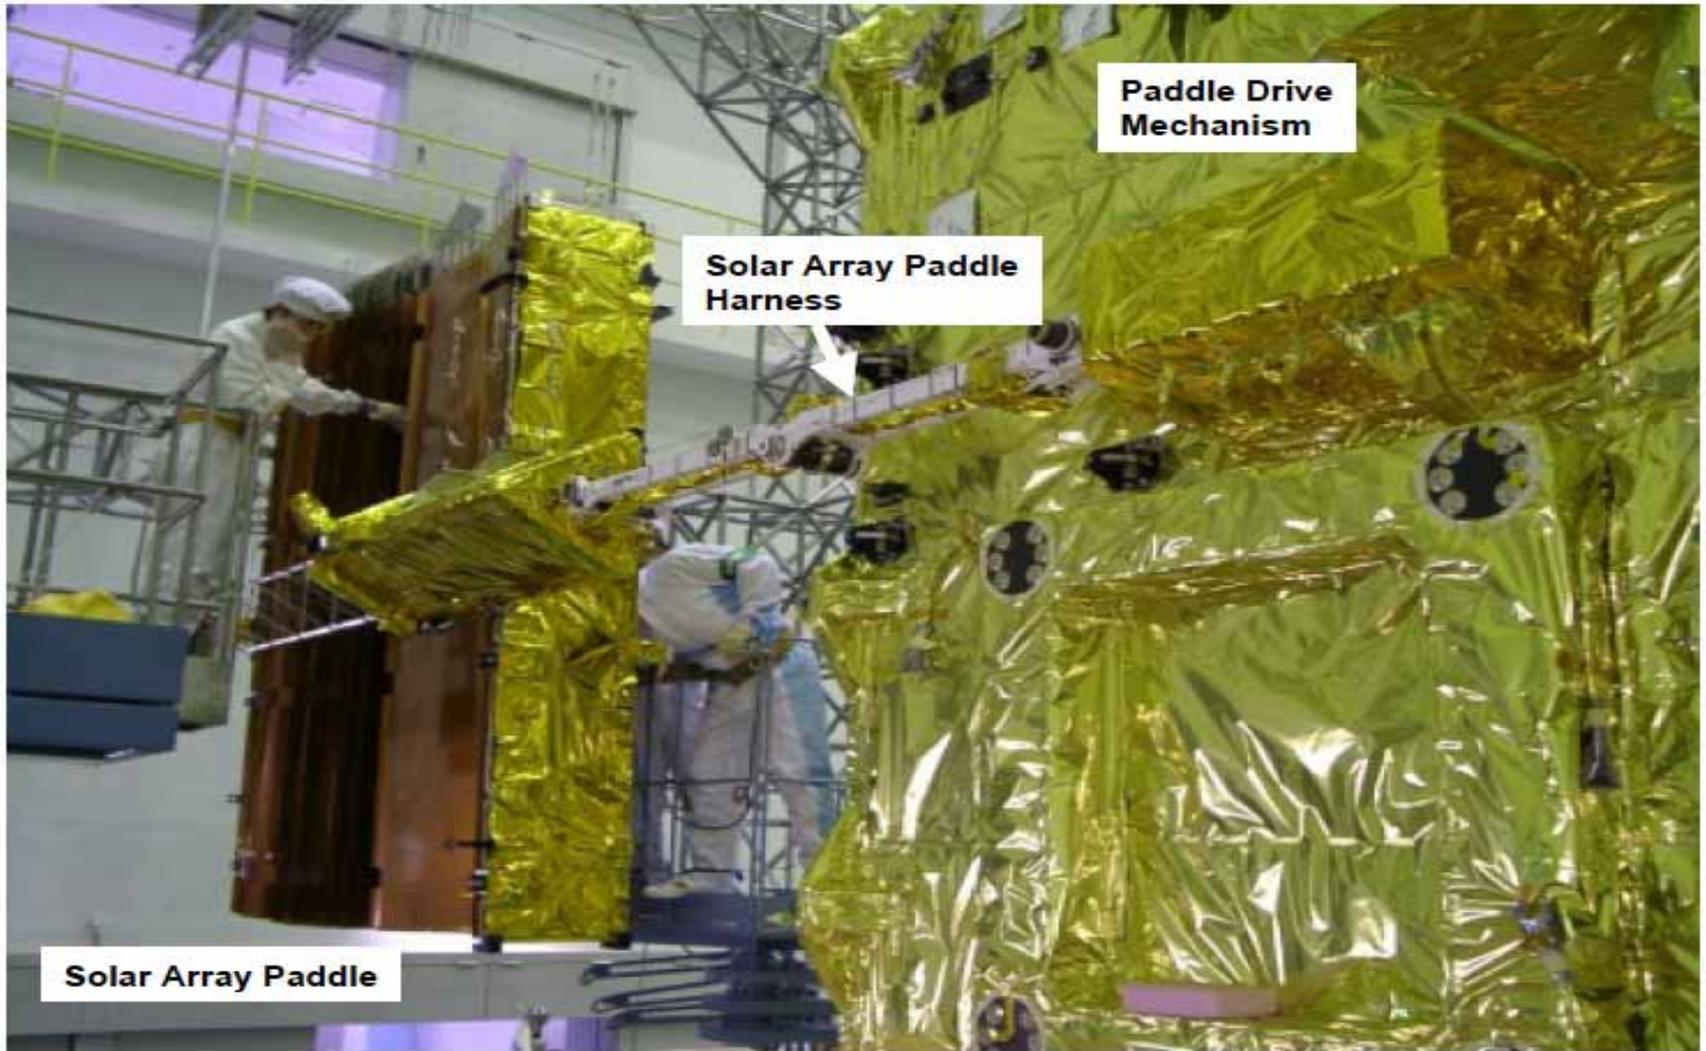
Photo of Solar Array Harness

Solar Paddle Harness outage is considered to have the highest possibility.
 → Anomaly on the one of two bundled harness can explain TLM behavior very well.
